ELEVATION NOTES:

2211 30TH STREET- FIRE STATION NO. 4

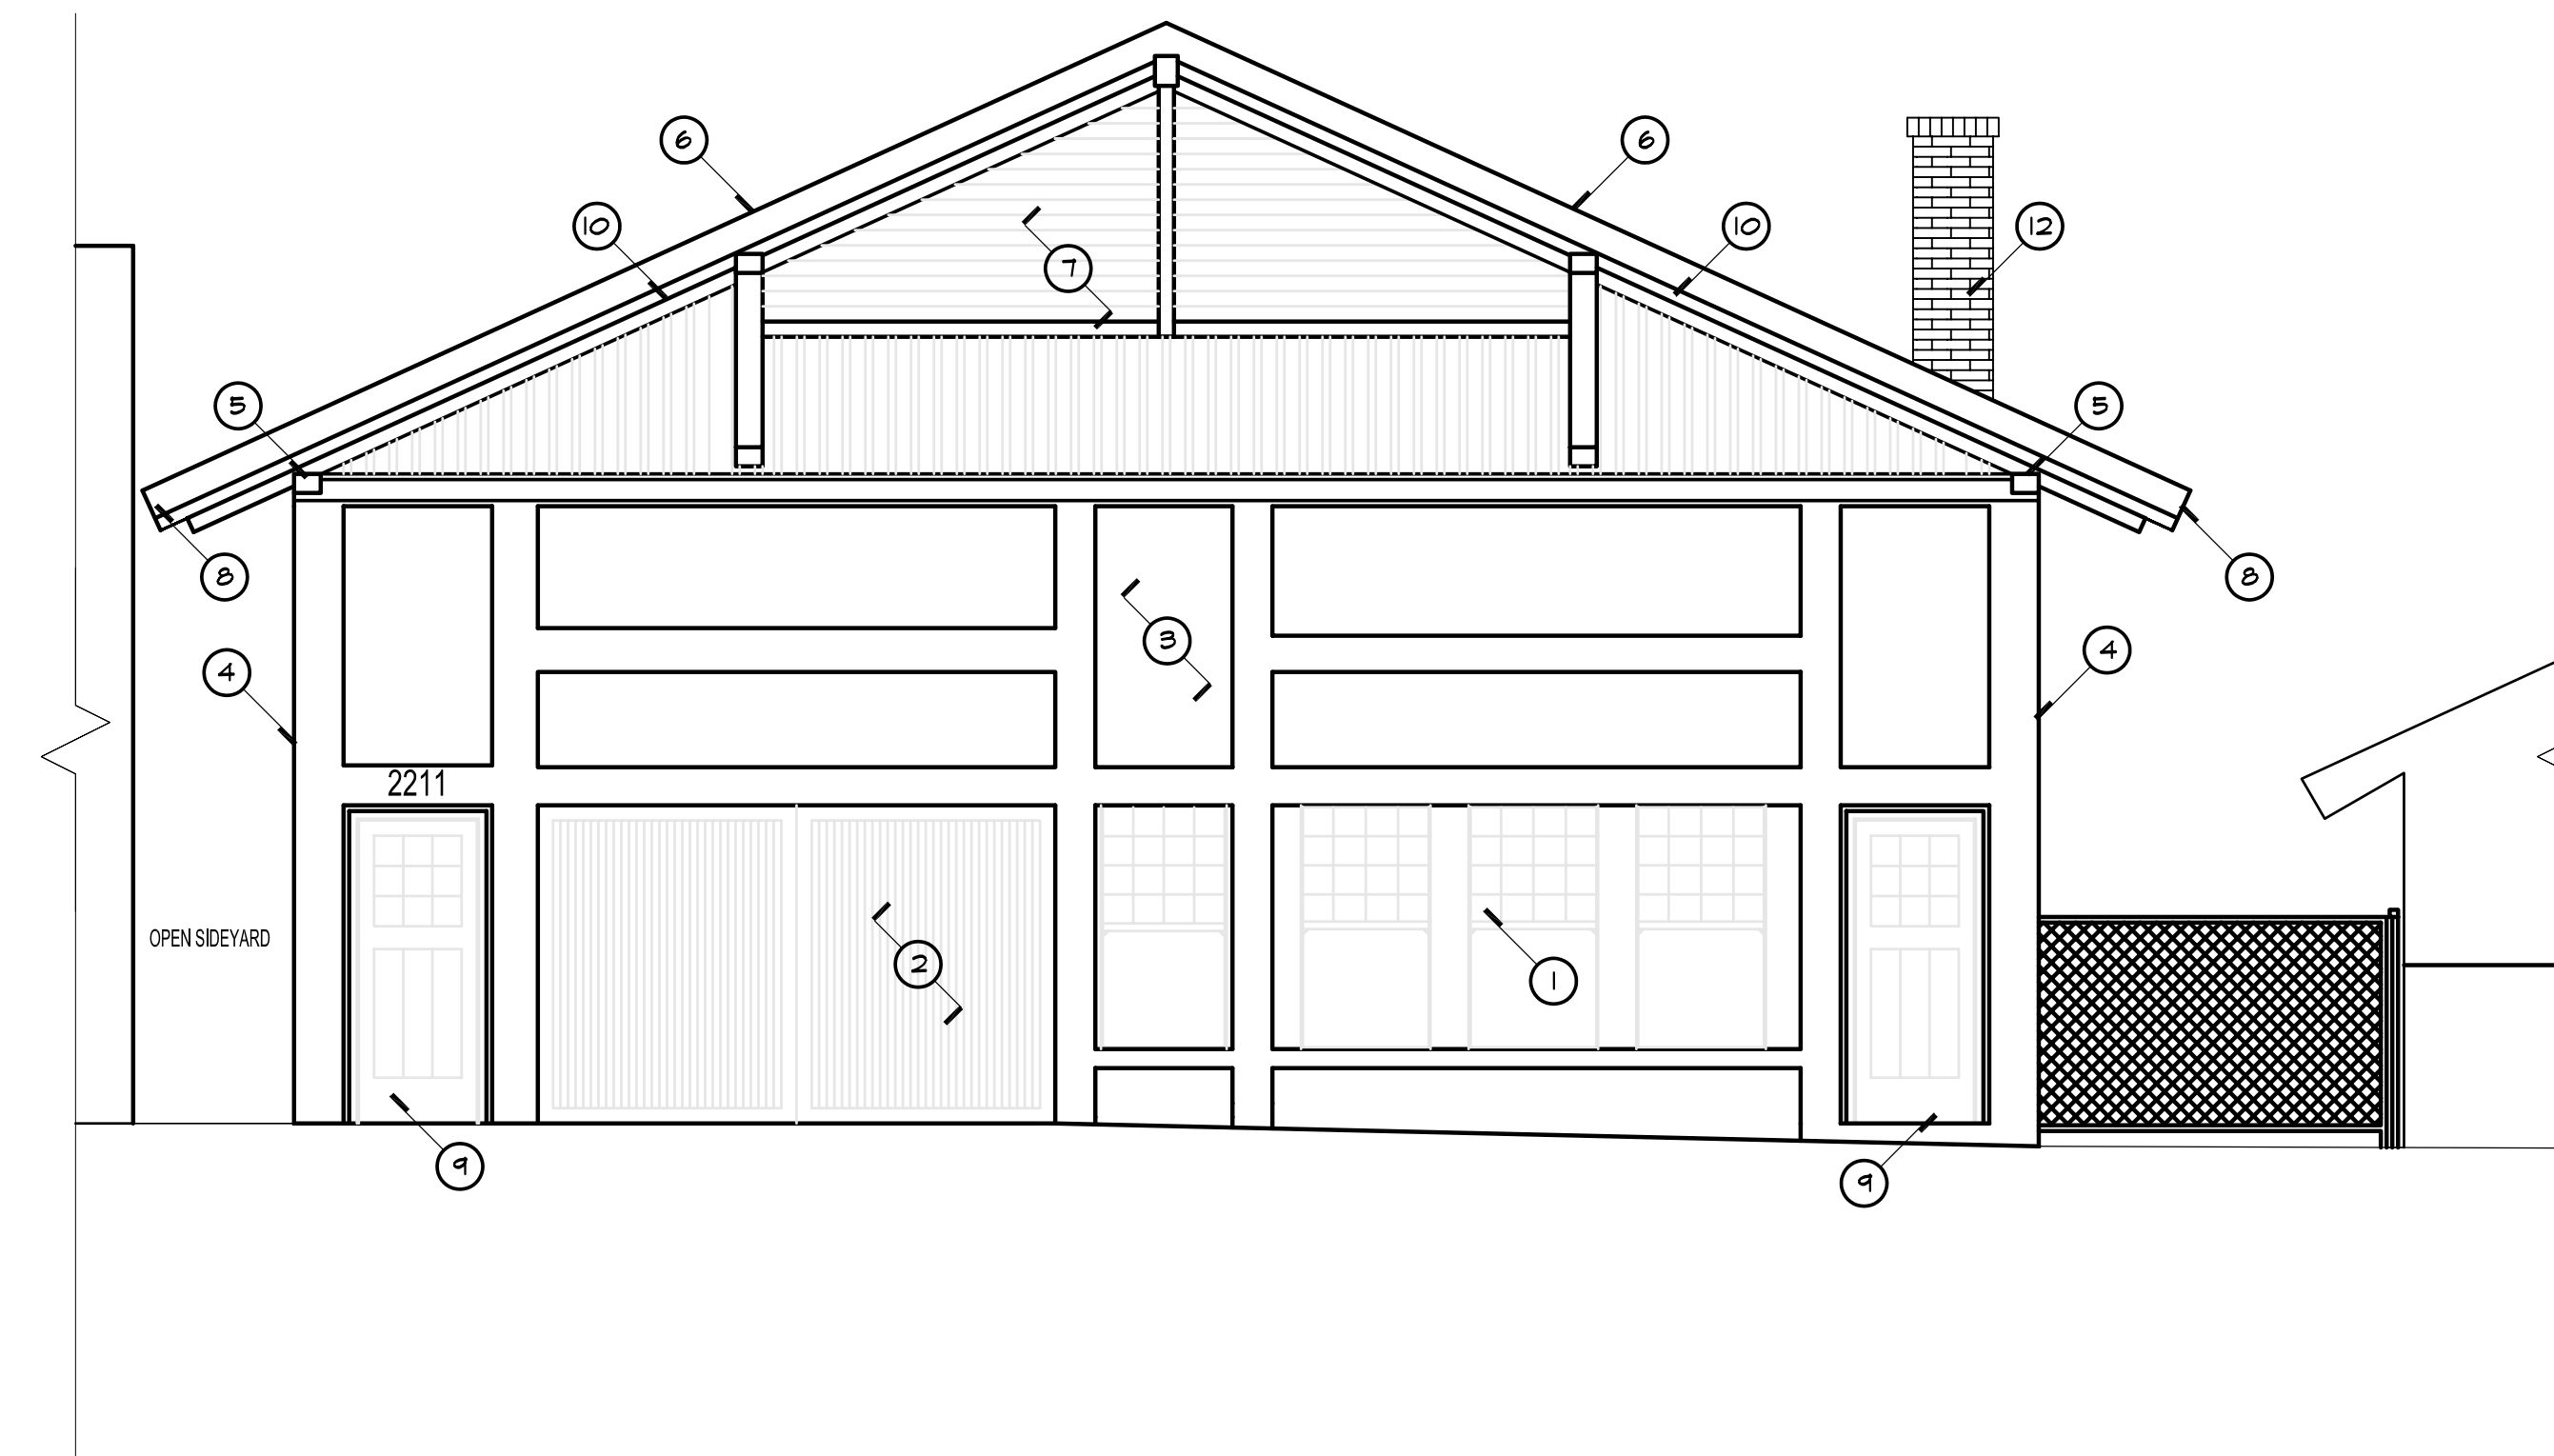
WEST ELEVATION

- ① THE BUILDING FRONT, SIDE AND REAR WINDOWS HAD MUCH OF THE GLASS BROKEN OUT AND HAD BEEN BOARDED UP FOR OVER 40 YEARS. RAINWATER DECAYED SOME OF THE WINDOWS TO THE POINT THAT A NUMBER OF THE WINDOWS REQUIRED SUBSTANTIAL REPAIR. THE WOOD WINDOWS WERE RESTORED TO THEIR EXACT DESIGN BY COPYING THE FRAMES AND FITTING IN PIECES OF THE EXACT WINDOW STYLE DESIGN AS THE ORIGINAL WINDOW STYLE. THE OLD GLASS PAINS THAT WERE NOT BROKEN WERE REMOVED WHILE THE FRAMES WERE REPAIRED THEN REINSTALLED. NEW MATCHING GLASS WAS INSTALLED IN ALL OF THE WINDOW OPENINGS THAT HAD BEEN BROKEN. THE WINDOW FRAMES AND WOOD TRIM WAS PAINTED TO MATCH THE ORIGINAL COLOR OF THE WINDOW FRAMES. THE WINDOWS AND TRIM WAS PAINTED WITH HIGH-GLOSS SHERWIN-WILLIAMS SW 2847 ROYCRAFT BOTTLE GREEN FROM THE HISTORIC PRESERVATION PALATE UNDER THE DIRECTION AND GUIDANCE OF BRUCE COONS OF THE SAVE OUR HERITAGE ORGANIZATION. PHOTOGRAPHS DATING TO 1914 INDICATED THAT SEVERAL PANELS ON THE FRONT OF THE BUILDING WERE VENEERED WITH BRICK BUT AT SOME LATER DATE STUCCO WAS APPLIED OVER THE VANEER. AN ANALYSIS OF THE AVAILABLE MEANS TO REMOVE THE STUCCO TO EXPOSE THE ORIGINAL BRICK VANEER INDICATED THAT THE BRICKS WOULD BE SUBSTANTIALLY DAMAGED SO NO ATTEMPT WAS MADE TO REMOVE THE STUCCO COAT PUT OVER THE VANEER.

- ② THE DOUBLE DOORS ON THE FRONT OF THE BUILDING WERE SUBSTANTIALLY DAMAGED AS A RESULT OF USE AS THE FIRE STATION AND LATER FOR STORAGE. THE DOOR STRUCTURAL FRAME HAS BEEN RETAINED HOWEVER THE QUALITY OF THE TENANTS THAT COULD BE ATTRACTED WITHOUT A SUBSTANTIAL REFRESH WOULD NOT HAVE ALLOWED FOR THE ECONOMIC VIABILITY OF THE BUILDING OR PROJECT. NEW SKINS WERE PUT ON THE DOORS AND WERE CUSTOM MADE BY HAND BY A LOCAL FINISH CARPENTER IN THE EXACT DESIGN AND MATERIALS AS HAD BEEN DONE ORIGINALLY. ALL OF THE HARDWARE WAS REPAIRED WHERE POSSIBLE AND REPLACED WITH THE SAME STYLE AND DESIGN WHERE NECESSARY.

- ③ ORIGINAL EXTERIOR WALL FINISH ON THE BUILDING WAS STUCCO OVER HOLLOW-CLAY-TILE MASONRY. AS A RESULT OF STRUCTURAL DEFICIENCIES FROM USING ARCHAIC BUILDING MATERIALS AND 96 YEARS OF EARTHQUAKES THE STUCCO SURFACE ON THE BUILDING WAS CRACKED AND DETERIORATED IN A NUMBER OF PLACES. THE SURFACE WAS PRESSURE WASHED, STUCCO ADHESIVE WAS APPLIED, AND THEN A MEDIUM-SAND FINISH COAT (COLOR-TECH EXTERIOR PREMIUM STUCCO) WAS INSTALLED PER INDUSTRY STANDARDS. BILL HOLTZ, CITY INSPECTOR, VIEWED THE APPLICATION. THE STUCCO SURFACES WERE REPAINTED WITH SHERWIN-WILLIAMS DEEP-BASE SW 6374 TORCHLIGHT (INSERT PANELS) AND SHERWIN-WILLIAMS DEEP-BASE SW 6372 INVITING IVORY (PILASTERS, SILLS, & HEADERS). THE COLORS WERE SELECTED FROM THE HISTORIC PRESERVATION PALATE UNDER THE DIRECTION AND GUIDANCE OF BRUCE COONS OF THE SAVE OUR HERITAGE ORGANIZATION.

- ⑨ REPLACE BOTH MAN-DOORS AT THE ENTRY TO MATCH THE SINGLE EXISTING ORIGINAL DOOR, THAT WAS TOO DETERIORATED TO REUSE, WITH MATCHING FRAMING, TRIM AND GLAZING. WOOD FINISHES ARE HONEY-COLORED NATURAL STAINS AND VARNISHES.

- ④ ANY EXPOSED BROKEN MASONRY WAS REPAIRED WITH ORIGINAL MASONRY FOUND ON-SITE. SUCH MASONRY REPAIRS INCLUDE RE-POINTED GROUT THROUGHOUT WITH GROUT COLOR MIXED TO MATCH THE ORIGINAL POINTING.

- ⑤ STRUCTURAL REPAIRS INCLUDED MEETING THE CITY OF SAN DIEGO'S UNREINFORCED MASONRY CODE UPGRADES PER SECTION 145.0410 OF THE SAN DIEGO MUNICIPAL ORDINANCE - TENSION ANCHORS AT THE ROOF-TO-WALL CONNECTION AND PARAPET BRACES WERE ADDED.

- ⑥ NEW ROOFING - 30 YEAR LAMINATE ASPHALT SHINGLES WERE INSTALLED CHATEAU GREEN COLOR OVER NEW PLYWOOD SHEATHING ADDED FOR STRUCTURAL REINFORCING. THE NEW SHINGLES WERE OF SIMILAR STYLE AND DESIGN AS THE ORIGINAL ROOFING SHINGLES.

- ⑦ PAINT ON THE WOODEN SURFACES WAS DONE WITH HIGH-GLOSS SHERWIN-WILLIAMS SW 2847 ROYCRAFT BOTTLE GREEN. THE COLOR WAS SELECTED FROM THE HISTORIC PRESERVATION PALATE UNDER THE DIRECTION AND GUIDANCE OF BRUCE COONS OF THE SAVE OUR HERITAGE ORGANIZATION. PAINT ON THE STUCCO SURFACES WAS SHERWIN-WILLIAMS DEEP-BASE SW 6374 TORCHLIGHT (INSERT PANELS) AND SHERWIN-WILLIAMS DEEP-BASE SW 6372 INVITING IVORY (PILASTERS, SILLS, & HEADERS). SELECTED FROM THE HISTORIC PRESERVATION PALATE ALSO UNDER THE DIRECTION AND GUIDANCE OF BRUCE COONS OF THE SAVE OUR HERITAGE ORGANIZATION.

- ⑧ INSTALLED NEW 26 GAUGE "BUTTERMAN'S CHOICE" ALUMINUM GUTTERS AND DOWNSPOUTS - ANODIZED IN ROYAL BROWN #05 COLOR, 5K STYLE TO MATCH ORIGINAL GUTTERS THAT HAD BEEN SUBSTANTIALLY DESTROYED.

- ⑩ REPAIRED AND PAINTED GABLES, GABLE RAFTERS, EAVES AND OVERHANGS. PRESSURE WASHED ALL SURFACES, THEN REPAIRED WOOD SURFACES WITH EPOXY FILLERS. REPLACED SEVERAL OVERHANG SHEATHING BOARDS WITH MATCHING ORIGINAL BOARDS FOUND ON-SITE.

- ⑪ INSTALLING "FIRE STATION NO. 4" LETTERING AT THE ORIGINAL LOCATION. LETTERING TO BE GOLD COLORED FORMED PLASTIC TO MATCH THE ORIGINAL LETTERING AS CLOSE AS POSSIBLE - THE FONT THAT "HELVEITICA MED. CONDITION".

- ⑫ EXISTING CHIMNEY TO BE RETROFITTED. THE APPEARANCE IS TO BE UNCHANGED.
