ELEVATION NOTES:

2211 30TH STREET- FIRE STATION NO. 9

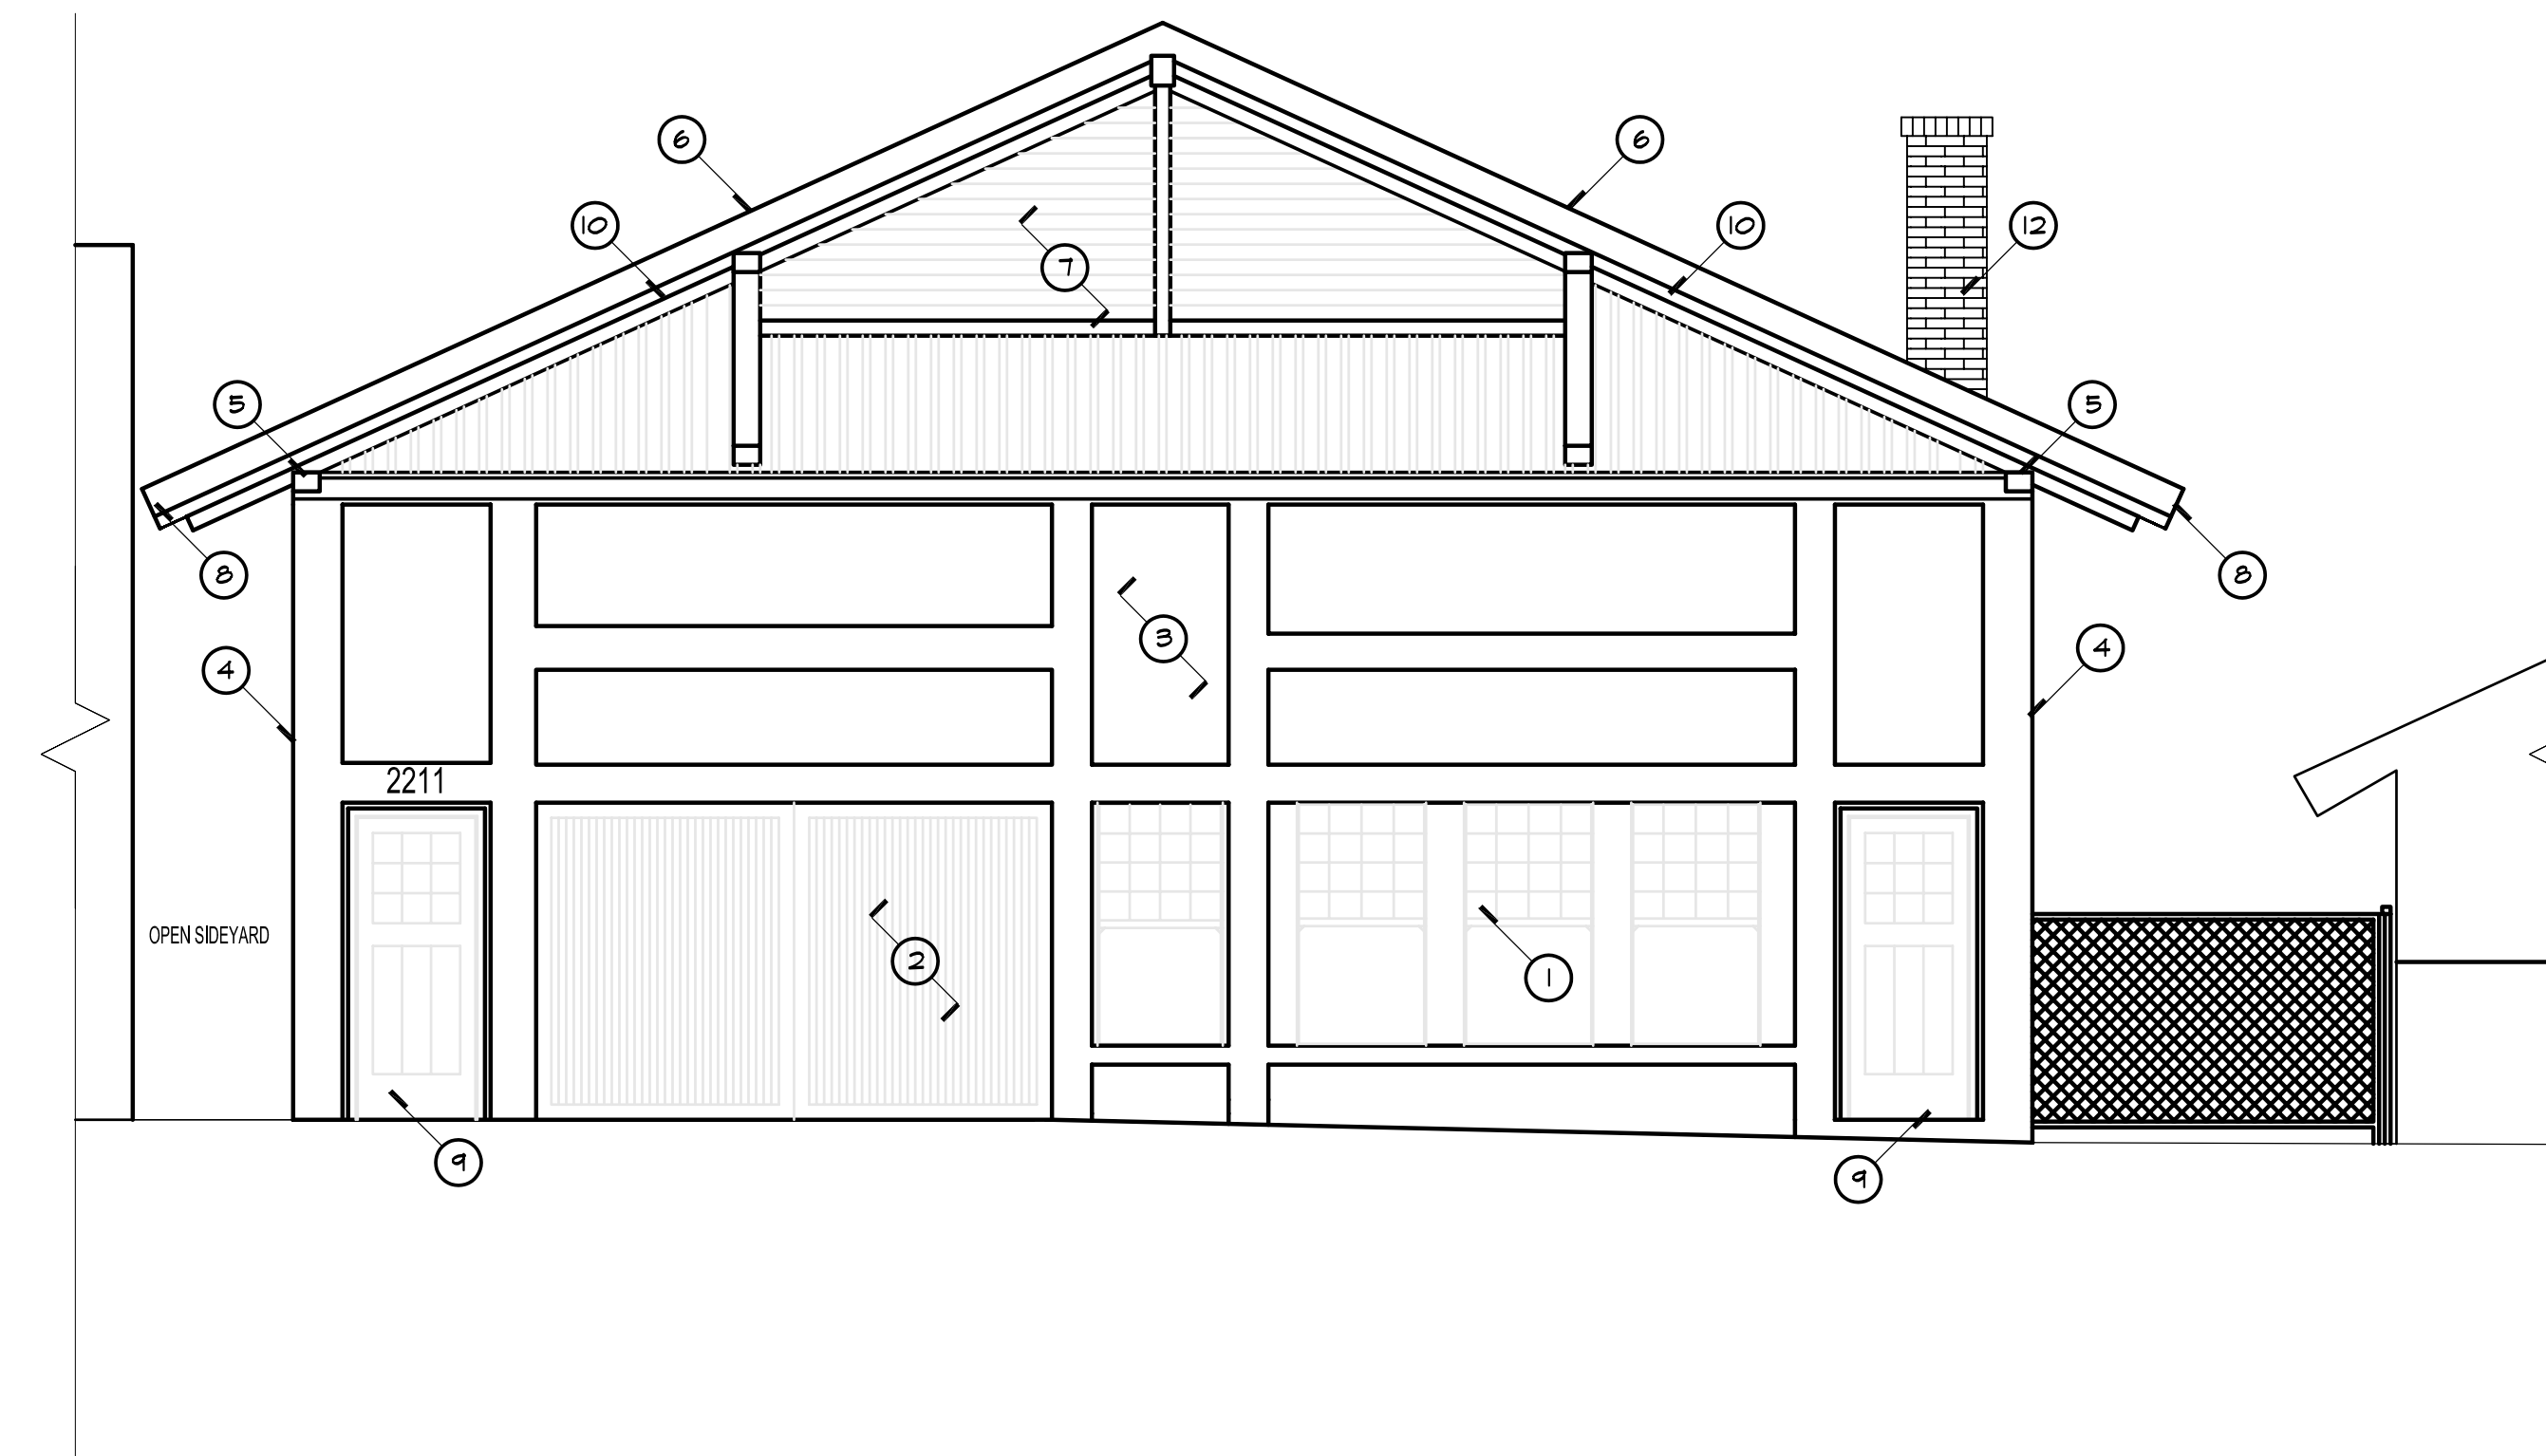
WEST ELEVATION

- ① THE BUILDING FRONT, SIDE AND REAR WINDOWS HAD MUCH OF THE GLASS BROKEN OUT AND HAD BEEN BOARDED UP FOR OVER 40 YEARS. RAINWATER DECAYED SOME OF THE WINDOWS TO THE POINT THAT A NUMBER OF THE WINDOWS REQUIRED SUBSTANTIAL REPAIR. THE WOOD WINDOWS WERE RESTORED TO THEIR EXACT DESIGN BY COPYING THE FRAMES AND FITTING IN PIECES OF THE EXACT WINDOW STYLE DESIGN AS THE ORIGINAL WINDOW STYLE. THE OLD GLASS PAINS THAT WERE NOT BROKEN WERE REMOVED WHILE THE FRAMES WERE REPAIRED THEN REINSTALLED. NEW MATCHING GLASS WAS INSTALLED IN ALL OF THE WINDOW OPENINGS THAT HAD BEEN BROKEN. THE WINDOW FRAMES AND WOOD TRIM WAS PAINTED TO MATCH THE ORIGINAL COLOR OF THE WINDOW FRAMES. THE WINDOWS AND TRIM WAS PAINTED WITH HIGH-GLOSS SHERWIN-WILLIAMS SW 2847 ROYCRAFT BOTTLE GREEN FROM THE HISTORIC PRESERVATION PALATE UNDER THE DIRECTION AND GUIDANCE OF BRUCE COONS OF THE SAVE OUR HERITAGE ORGANIZATION. PHOTOGRAPHS DATING TO 1914 INDICATED THAT SEVERAL PANELS ON THE FRONT OF THE BUILDING WERE VENEERED WITH BRICK BUT AT SOME LATER DATE STUCCO WAS APPLIED OVER THE VANEER. AN ANALYSIS OF THE AVAILABLE MEANS TO REMOVE THE STUCCO TO EXPOSE THE ORIGINAL BRICK VANEER INDICATED THAT THE BRICKS WOULD BE SUBSTANTIALLY DAMAGED SO NO ATTEMPT WAS MADE TO REMOVE THE STUCCO COAT PUT OVER THE VANEER.

- ② THE DOUBLE DOORS ON THE FRONT OF THE BUILDING WERE SUBSTANTIALLY DAMAGED AS A RESULT OF USE AS THE FIRE STATION AND LATER FOR STORAGE. THE DOOR STRUCTURAL FRAME HAS BEEN RETAINED HOWEVER THE QUALITY OF THE TENANTS THAT COULD BE ATTRACTED WITHOUT A SUBSTANTIAL REFRESH WOULD NOT HAVE ALLOWED FOR THE ECONOMIC VIABILITY OF THE BUILDING OR PROJECT. NEW SKINS WERE PUT ON THE DOORS AND WERE CUSTOM MADE BY HAND BY A LOCAL FINISH CARPENTER IN THE EXACT DESIGN AND MATERIALS AS HAD BEEN DONE ORIGINALLY. ALL OF THE HARDWARE WAS REPAIRED WHERE POSSIBLE AND REPLACED WITH THE SAME STYLE AND DESIGN WHERE NECESSARY.

- ③ ORIGINAL EXTERIOR WALL FINISH ON THE BUILDING WAS STUCCO OVER HOLLOW-CLAY-TILE MASONRY. AS A RESULT OF STRUCTURAL DEFICIENCIES FROM USING ARCHAIC BUILDING MATERIALS AND 96 YEARS OF EARTHQUAKES THE STUCCO SURFACE ON THE BUILDING WAS CRACKED AND DETERIORATED IN A NUMBER OF PLACES. THE SURFACE WAS PRESSURE WASHED, STUCCO ADHESIVE WAS APPLIED, AND THEN A MEDIUM-SAND FINISH COAT (COLOR-TECH EXTERIOR PREMIUM STUCCO) WAS INSTALLED PER INDUSTRY STANDARDS. BILL HOLTZ, CITY INSPECTOR, VIEWED THE APPLICATION. THE STUCCO SURFACES WERE REPAINTED WITH SHERWIN-WILLIAMS DEEP-BASE SW 6374 TORCHLIGHT (INSERT PANELS) AND SHERWIN-WILLIAMS DEEP-BASE SW 6372 INVITING IVORY (PILASTERS, SILLS, & HEADERS). THE COLORS WERE SELECTED FROM THE HISTORIC PRESERVATION PALATE UNDER THE DIRECTION AND GUIDANCE OF BRUCE COONS OF THE SAVE OUR HERITAGE ORGANIZATION.

- ⑧ INSTALLED NEW 26 GAUGE "BUTTERMAN'S CHOICE" ALUMINUM GUTTERS AND DOWNSPOUTS - ANODIZED IN ROYAL BROWN #05 COLOR, 5K STYLE TO MATCH ORIGINAL GUTTERS THAT HAD BEEN SUBSTANTIALLY DESTROYED.

- ⑨ REPLACE BOTH MAN-DOORS AT THE ENTRY TO MATCH THE SINGLE EXISTING ORIGINAL DOOR, THAT WAS TOO DETERIORATED TO REUSE, WITH MATCHING FRAMING, TRIM AND GLAZING. WOOD FINISHES ARE HONEY-COLORED NATURAL STAINS AND VARNISHES.

- ⑩ REPAIRED AND PAINTED GABLES, GABLE RAFTERS, EAVES AND OVERHANGS. PRESSURE WASHED ALL SURFACES, THEN REPAIRED WOOD SURFACES WITH EPOXY FILLERS. REPLACED SEVERAL OVERHANG SHEATHING BOARDS WITH MATCHING ORIGINAL BOARDS FOUND ON-SITE.

- ④ ANY EXPOSED BROKEN MASONRY WAS REPAIRED WITH ORIGINAL MASONRY FOUND ON-SITE. SUCH MASONRY REPAIRS INCLUDE RE-POINTED GROUT THROUGHOUT WITH GROUT COLOR MIXED TO MATCH THE ORIGINAL POINTING.

- ⑤ STRUCTURAL REPAIRS INCLUDED MEETING THE CITY OF SAN DIEGO'S UNREINFORCED MASONRY CODE UPGRADES PER SECTION 145.0410 OF THE SAN DIEGO MUNICIPAL ORDINANCE - TENSION ANCHORS AT THE ROOF-TO-WALL CONNECTION AND PARAPET BRACES WERE ADDED.

- ⑥ NEW ROOFING - 30 YEAR LAMINATE ASPHALT SHINGLES WERE INSTALLED CHATEAU GREEN COLOR OVER NEW PLYWOOD SHEATHING ADDED FOR STRUCTURAL REINFORCING. THE NEW SHINGLES WERE OF SIMILAR STYLE AND DESIGN AS THE ORIGINAL ROOFING SHINGLES.

- ⑦ PAINT ON THE WOODEN SURFACES WAS DONE WITH HIGH-GLOSS SHERWIN-WILLIAMS SW 2847 ROYCRAFT BOTTLE GREEN. THE COLOR WAS SELECTED FROM THE HISTORIC PRESERVATION PALATE UNDER THE DIRECTION AND GUIDANCE OF BRUCE COONS OF THE SAVE OUR HERITAGE ORGANIZATION. PAINT ON THE STUCCO SURFACES WAS SHERWIN-WILLIAMS DEEP-BASE SW 6374 TORCHLIGHT (INSERT PANELS) AND SHERWIN-WILLIAMS DEEP-BASE SW 6372 INVITING IVORY (PILASTERS, SILLS, & HEADERS). SELECTED FROM THE HISTORIC PRESERVATION PALATE ALSO UNDER THE DIRECTION AND GUIDANCE OF BRUCE COONS OF THE SAVE OUR HERITAGE ORGANIZATION.

- ⑪ INSTALLING "FIRE STATION NO. 9" LETTERING AT THE ORIGINAL LOCATION. LETTERING TO BE GOLD COLORED FORMED PLASTIC TO MATCH THE ORIGINAL LETTERING AS CLOSE AS POSSIBLE - THE FONT THAT "HELVEITICA MED. CONDITION".

- ⑫ EXISTING CHIMNEY TO BE RETROFITTED. THE APPEARANCE IS TO BE UNCHANGED.
